# IF THE **SHOE** FITS

Many of the risks associated with re-lining brake shoes are avoidable and BPW looks at some of the causes of these failures and offers some simple steps to minimise the risk.

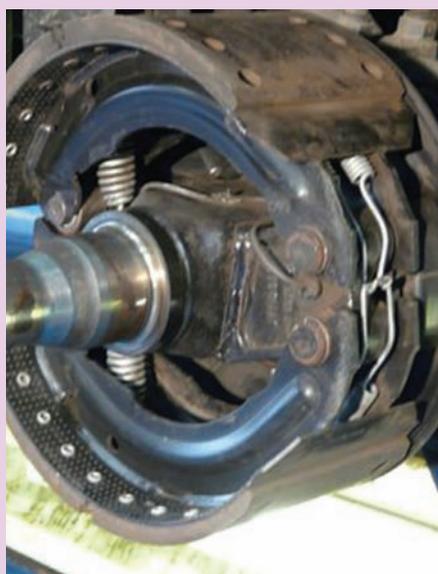
1. Anchor retaining springs in position

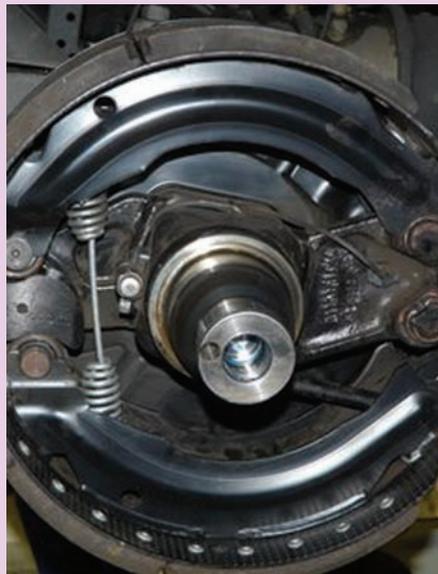
2. To dismantle, the brake shoes are simply levered off.

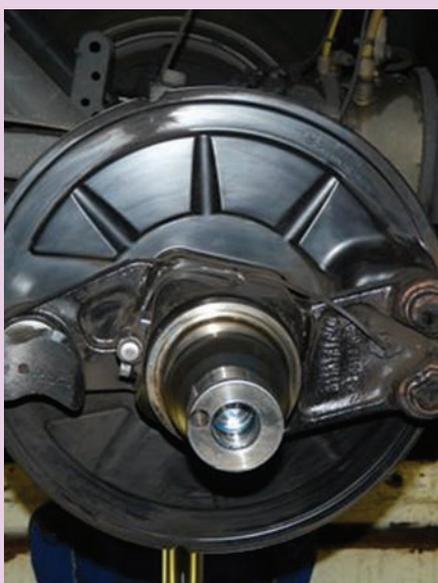
3. The brake shoes are dismantled.

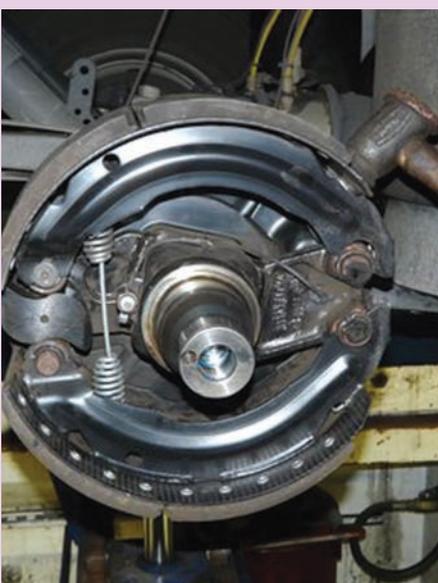
4. The new brake shoes are positioned and located with a soft hammer. Anchor retaining springs are re-fastened.

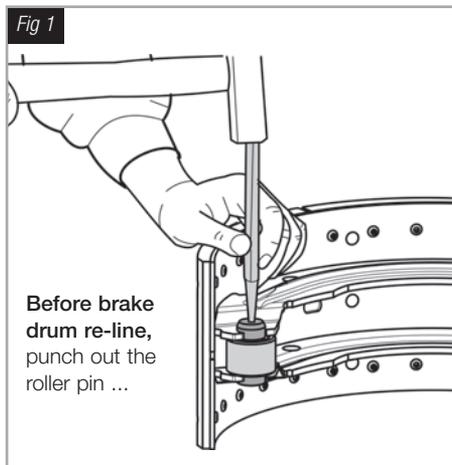
(C) Remove the cam rollers from your shoes (**Fig 1**) before sending them for re-lining. This will prevent the rollers being damaged, painted or contaminated during shot blasting. When re-fitting the roller you must ensure that the cam roller bearing is greased prior to re-assembly (use *BPW's ECO Li grease for optimum results*).

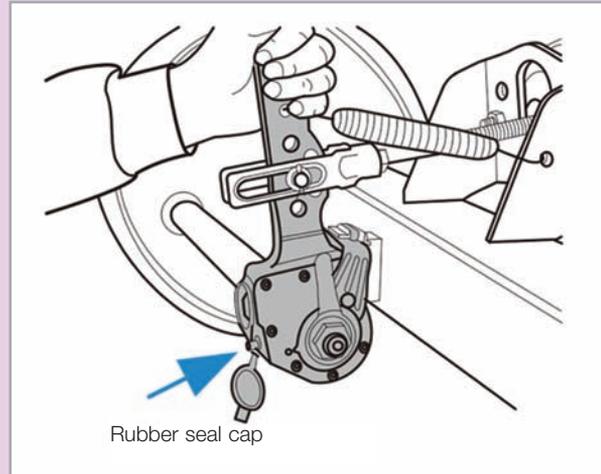
### Checking operation of the slack adjuster

A play of at least 50mm with a lever length of 150mm must be available. Actuate the brake lever several times by hand. When this is done, automatic adjustment must take

place smoothly. Engagement of the clutch coupling is audible and on the return stroke the adjustment screw turns slightly in a clockwise direction. Grease with BPW ECO-Li Plus.

Set the freeplay by disengaging the clutch on the slack adjuster and turning clockwise until brake bind is achieved, proceed to turn 180° anti-clockwise to achieve between 0.7 – 1.0mm lining to drum clearance. Position the brake lining indicator in the vertical position and tighten the camshaft nut to 60 – 70Nm.

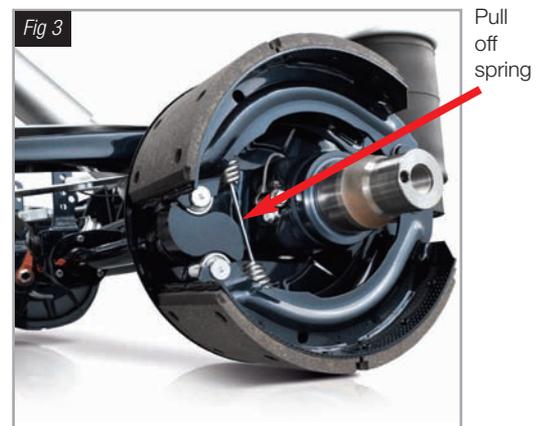
(E) When fitting newly lined shoes, **ALWAYS** replace the pull-off spring to ensure the shoe does not contact or drag against the brake drum. Check the tension of the “C” clip and replace if necessary. **DO NOT** grease the camshaft head as this needs the friction to work effectively. (See **Fig 3**).
